DEPARTMENT OF TRANSPORTATION

Quality Assurance and Source Inspection

Contract #: 04-0120F4Cty: SF/ALA Rte: 80 PM: 13.2/13.9File #: 69.28**WELDING INSPECTION REPORT****Resident Engineer:** Pursell, Gary**Address:** 333 Burma Road**City:** Oakland, CA 94607**Report No:** WIR-000172**Date Inspected:** 15-May-2007**Project Name:** SAS Superstructure**OSM Arrival Time:** 800**Prime Contractor:** American Bridge/Fluor Enterprises, a JV**OSM Departure Time:** 1730**Contractor:** Zhenhua Port Machinery Company, Ltd (ZPMC), Changxing Island **Location:** Shanghai, China**CWI Name:** Huang Wei**CWI Present:** Yes No**Inspected CWI report:** Yes No N/A**Rod Oven in Use:** Yes No N/A**Electrode to specification:** Yes No N/A**Weld Procedures Followed:** Yes No N/A**Qualified Welders:** Yes No N/A**Verified Joint Fit-up:** Yes No N/A**Approved Drawings:** Yes No N/A**Approved WPS:** Yes No N/A**Delayed / Cancelled:** Yes No N/A**Bridge No:** 34-0006**Component:** N/A**Summary of Items Observed:**

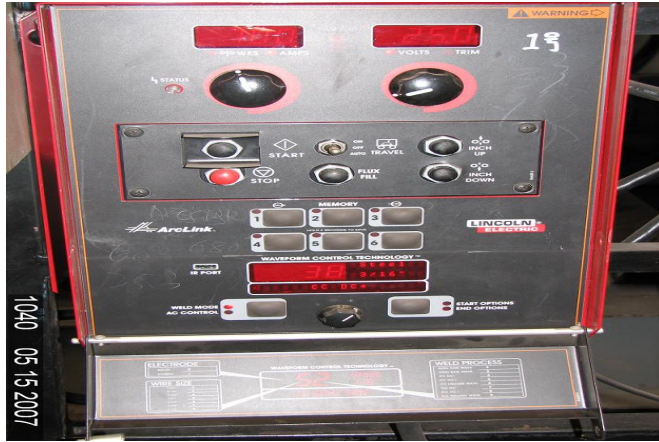
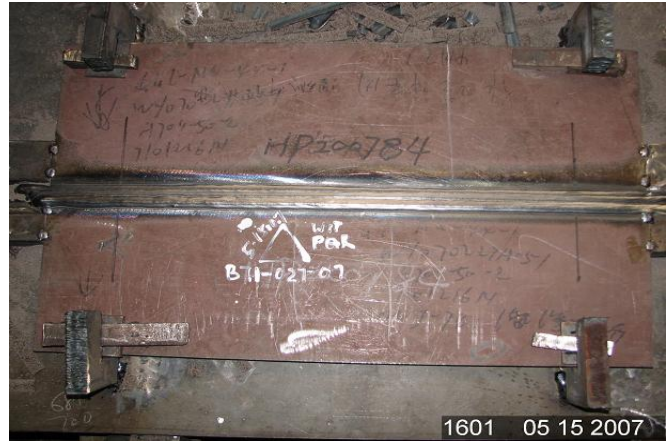
The QA inspector performed final visual examination to the test coupon after completion of the PQR HP200784. The QA inspector observed that the welds appeared to be in general compliance with the contract documents. The QA inspector assigned a lot # B71-027-07 on this date. The digital photograph below shows the PQR test coupon and the Gantry SAW machine (Lincoln) settings.

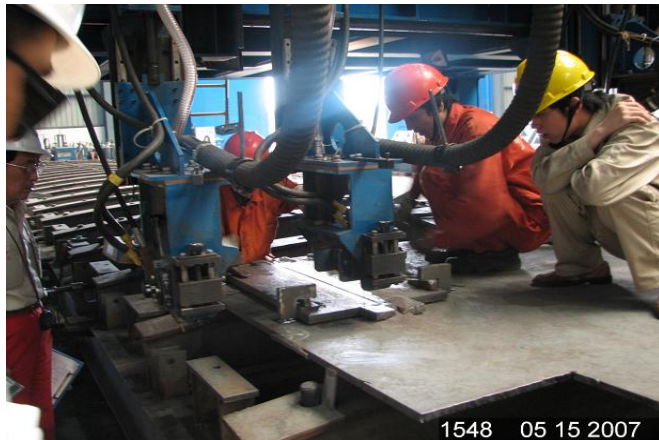
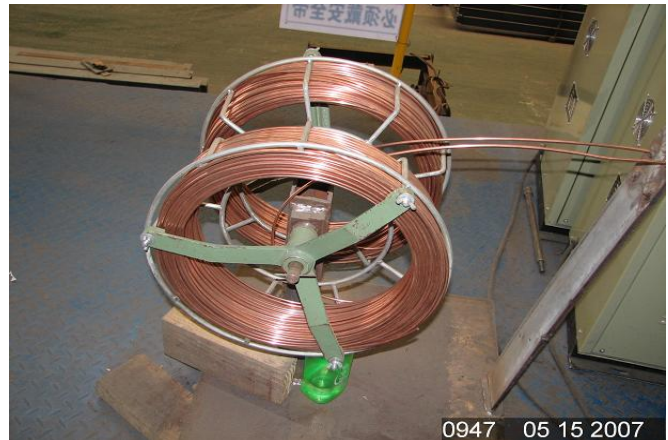
Mr. McClary and the QA inspector observed that the SAW electrodes JW-3 were not identified after ZPMC removed the wire spool from the electrode manufacturer box. Mr. McClary had a conversation with ZPMC/ABF representatives Mr. Huang and Mr. Song. Mr. McClary relayed to ZPMC that welding consumable used needed to be identified and traceable. ZPMC agreed. ZPMC labeled the electrode spool JW-3 used on the PQR HP200784.

The digital photograph below show the SAW spool JW-3 electrode without identification and ZPMC welding the PQR HP200784 on the Gantry welding machine.
